Confidential Inspection Report

LOCATED AT:
1600 Pennsylvania Ave
Chicago, Illinois 60630

INSPECTED ON:
Tuesday, December 27, 2022

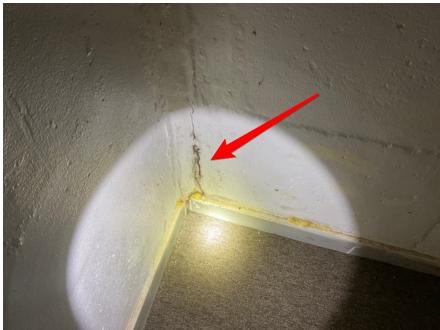
UPG There was one or more of the foundation cracks that are showing water leakage. Recommend further evaluation/sealing/repair by a licensed water proofing contractor.

Water stains

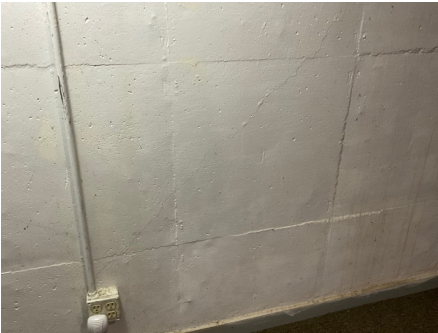
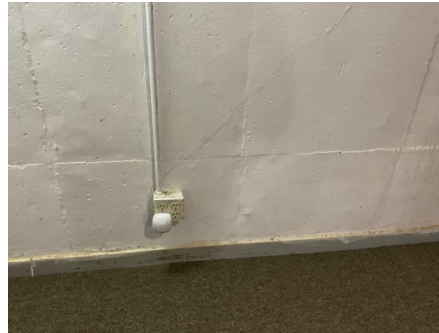
Hairline and/or small cracks, within normal tolerances, are visible. This type of cracking is often a result of shrinkage of materials and/or minor settlement and usually does not affect the strength of the foundation. No action is indicated.

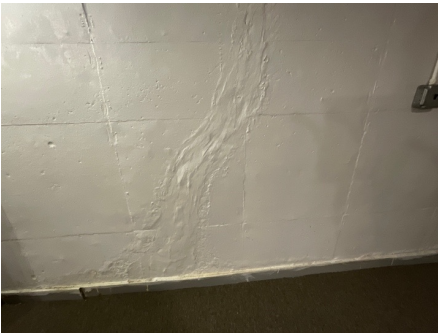
Larger than typical foundation settlement cracking and deterioration was observed in some locations. The amount of movement which has occurred is not likely to have caused other damage to the structure but this area should be repaired. If additional movement occurs, more costly repairs might be necessary. The rate of movement cannot be predicted during a one-time inspection.

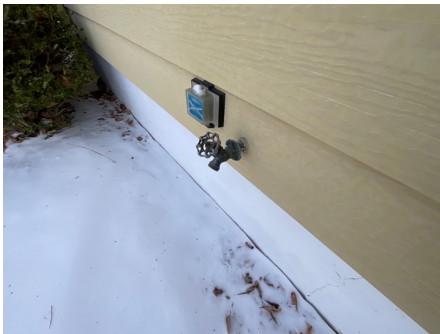
The exterior faucets were not of a type designed to prevent damage from freezing and will need to be shut off and drained as freezing weather approaches. It is recommended to replace with freeze-proof exterior spigot if necessary.

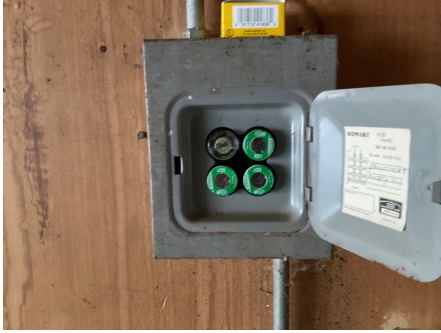
REP The subpanel is in serviceable condition with circuitry installed and fused correctly. The sub-panel does not meet present standards but upgrades are optional and would usually only be considered along with other improvements.

The circuitry in the panel is unlabeled. We recommend that each circuit be identified, allowing individuals unfamiliar with the equipment to operate it properly when and if necessary.

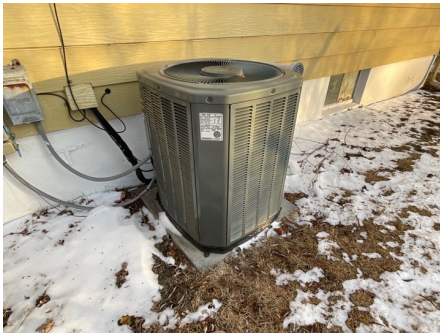
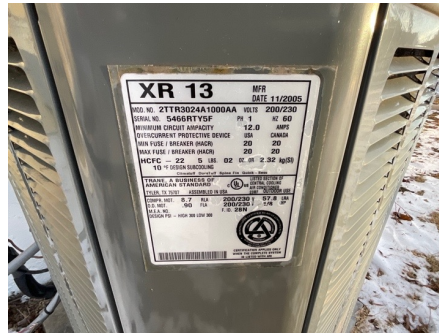
The air conditioner condenser a/c unit was old and dirty and appeared to be at or past its design life at the time of the inspection. The Inspector recommends evaluation service and certification by a qualified HVAC technician to more accurately determine the air conditioner condition and ensure that it is in the best possible working condition. Air conditioner unit was not tested because Out door temperature. The average central air conditioning system has a life expectancy of 15 years per NAHB study.

REP Operating an air condition system in cold weather can damage the compressor. The outside air temperature was determined to be too low for the safe operation of the equipment. We recommend inspection of the system with the return of warmer weather.

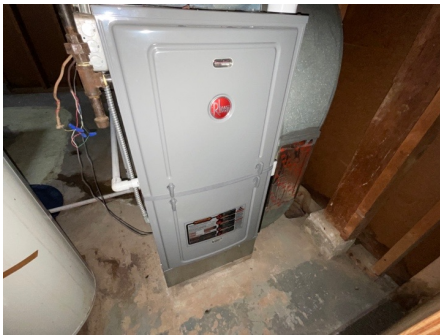
Rust-like corrosion inside the furnace below the exhaust flue indicated the presence of excessive amounts of moisture, typically related to condensation formed by improper furnace exhaust flue conditions. This condition may result in premature failure of furnace components. The Inspector recommends that the furnace be serviced by a qualified HVAC contractor.

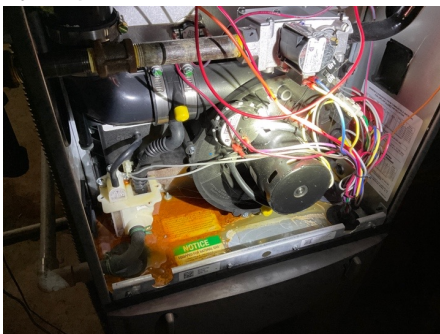
REP High-efficiency furnace exhaust produces condensate fluid which must be properly discharged. The condensate line for the high-efficiency furnace is leaking inside the cabinet and should be corrected by a qualified contractor.

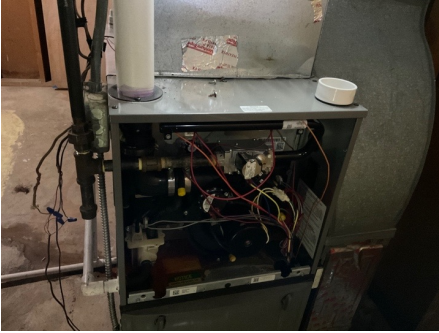
REP Newer furnace was found in serviceable condition however High mid- efficiency furnace Intake was terminate inside this room, Intake and exhaust pipes should be placed as close together as possible at termination end. The Inspector recommends furnace exhaust system further evaluation by a qualified contractor and made any corrections if necessary. Further info regarding exhaust systems you can visit <http://www.nrel.gov/docs/fy13osti/55493.pdf>

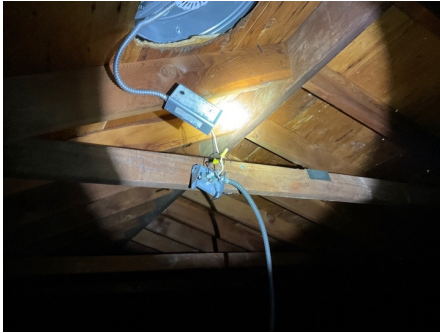
Electrical Splices

REP Running splices, which are improper connections outside of a junction box, were observed. We recommend connections be joined with approved connectors inside a junction box to prevent accidental contact or mechanical damage.

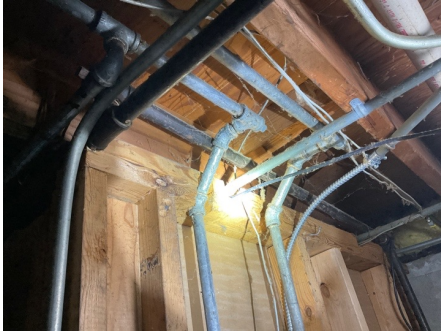
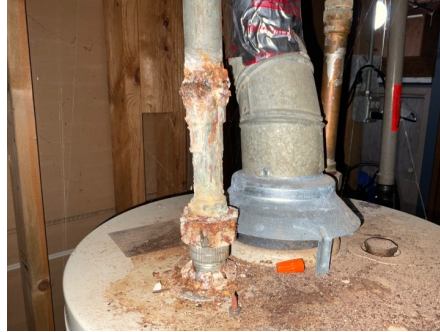
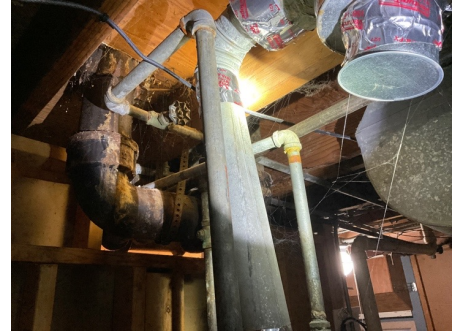
The home contained galvanized steel water distribution pipes. These pipes are outdated and subject to corrosion which will eventually result in restricted flow and leakage and will need to be replaced. Water flow in the home was satisfactory at the time of the inspection.

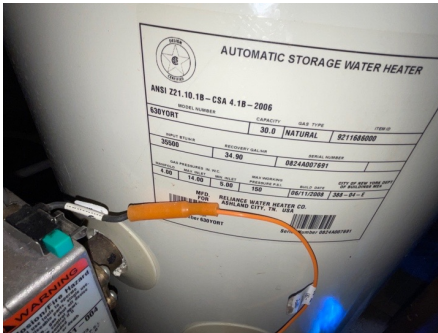
The water heater system is an old unit that may be approaching the end of its useful life. Predicting the frequency or time frame for repairs on any mechanical device is virtually impossible. Expect to replace any time during the next five years.

The gas-fired water heater was connected to the gas piping system using galvanized piping not allowed within this jurisdiction or gas utility company. This galvanized piping connection should be replaced with an approved gas black pipe by a qualified plumbing contractor.

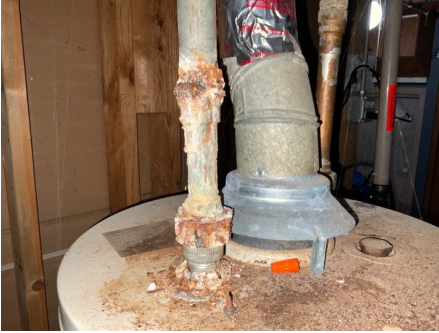
REP The water connections are heavily corroded and show signs of previous leakage. We recommend replacement.

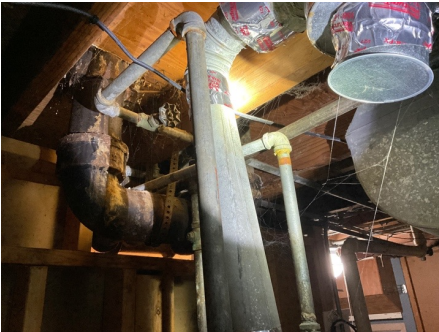
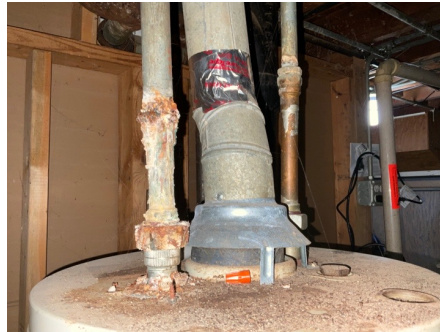
Sections of galvanized piping are connected directly to copper piping. We recommend these connections be equipped with dielectric unions or other approved fittings to limit corrosion and subsequent leakage.

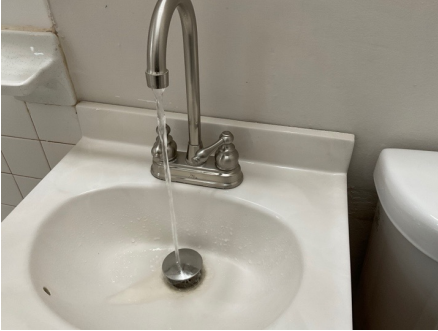
REP Inadequate water flow evident at this bathroom sink at the time of the inspection may be the result of a clogged aerator screen. If cleaning the aerator screen does not improve water flow, consider evaluation of this condition by a qualified plumbing contractor.

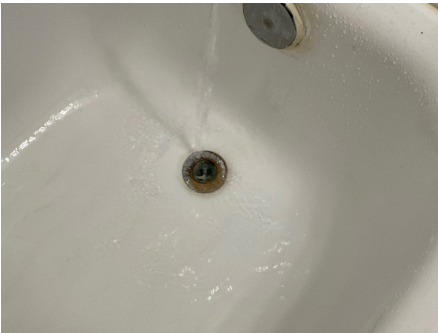
The drain stop is missing. We recommend it be replaced.

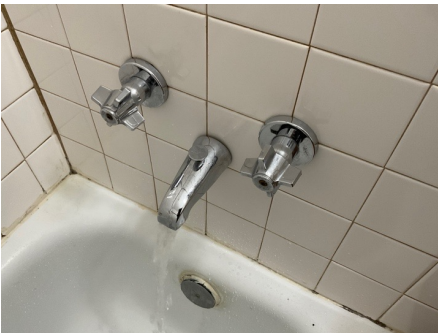
The tub rim is embedded by the tiled surround. This may be conducive to leakage. Extra care will be necessary to keep the rim well sealed to the tile to prevent moisture penetration.

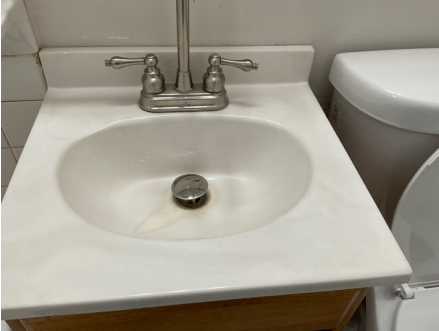
REP Sections of the countertop surface are separating from the counter. We recommend they be repaired or resecured.

The countertop is not secured to the base cabinet. We recommend it be secured to prevent damage to the plumbing connections and subsequent leakage.

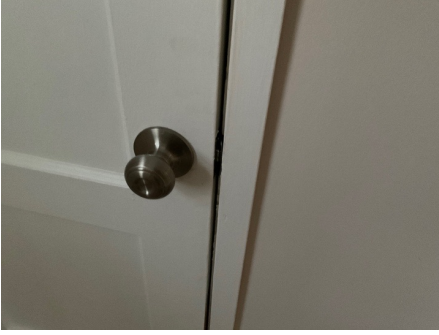
The closet door is not correctly aligned in the frame. We recommend it be realigned.

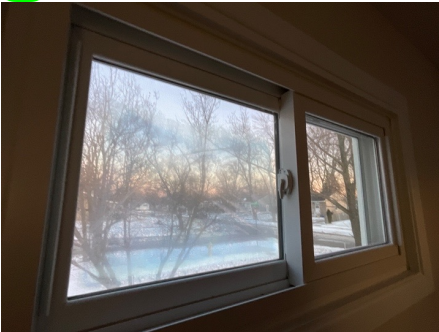
REP One or more panes of glass are broken. We recommend all broken glass be replaced.

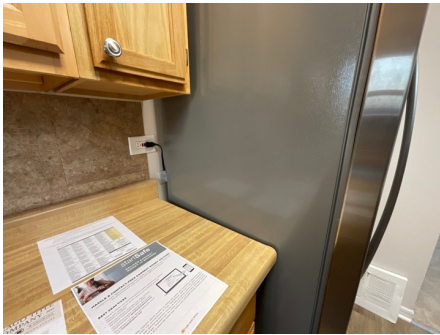
The refrigerator is plugged into an outlet which is wired in series with the kitchen counter GFCI outlet and is deactivated when the GFCI trips. The refrigerator should have its own circuit and should not be controlled by a GFCI device as the unnoticed tripping of that device can lead to spoilage of the food in the refrigerator.
