Confidential Inspection Report

LOCATED AT:
1600 Pennsylvania Ave
Chicago, Illinois 60630

INSPECTED ON:
Tuesday, December 27, 2022

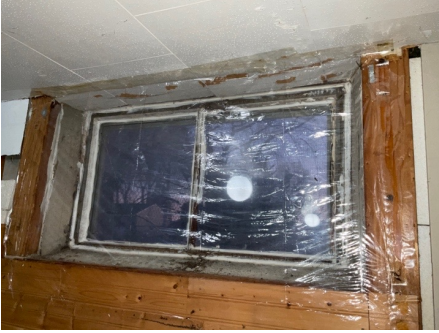
Basement windows are usually very difficult to open, and sometimes impossible to close. These windows were not tested. Only a visual inspection was performed.

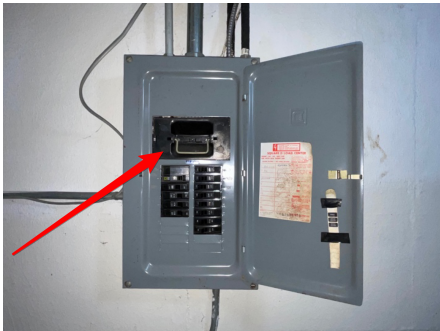
Main disconnect

The main disconnect is incorporated into the electrical service panel.

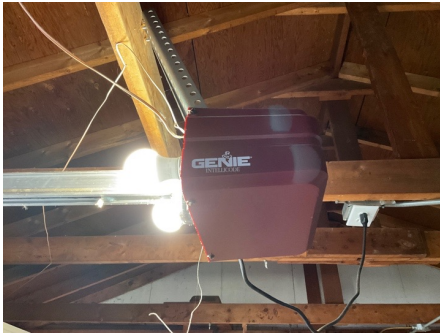
The automatic garage door opener responded to the controls at the time of the inspection

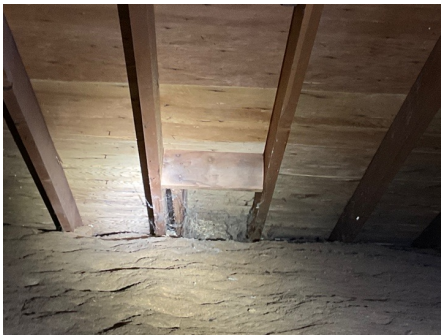
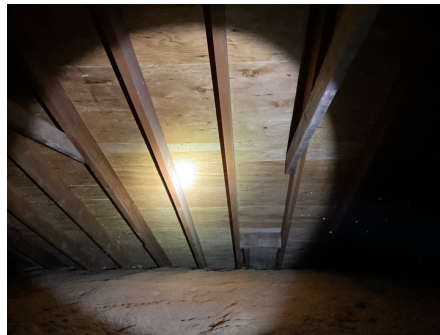
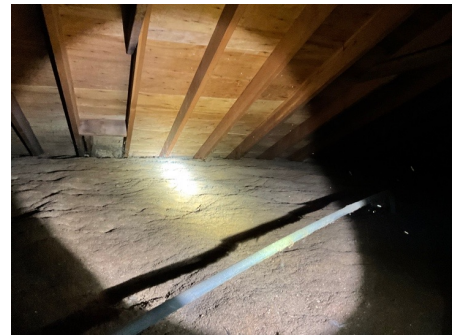
Due to limited clearances, only a partial inspection of the attic space was performed from the access opening. If access is required for maintenance, installation of secured walking planks above the ceiling joists would be a beneficial upgrade.

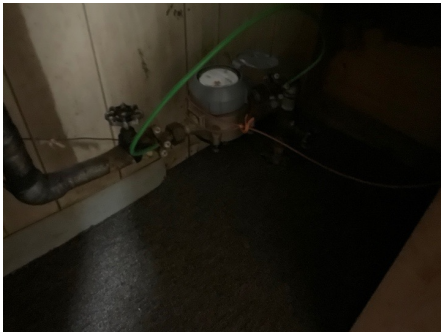
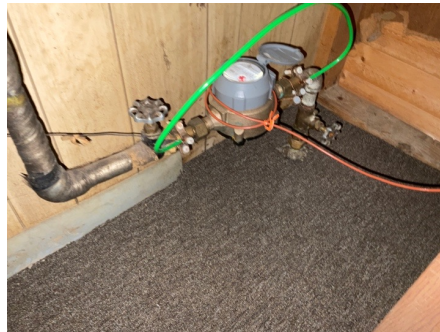
The domestic water supply main shut-off valve is on the front wall in the basement.

There was evidence of surface corrosion/oxidation, but no leakage, at the exposed and accessible main supply. This piping should be monitored and repaired if necessary.

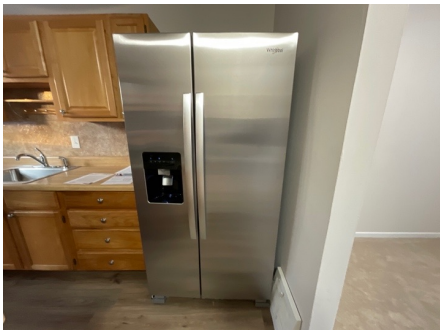
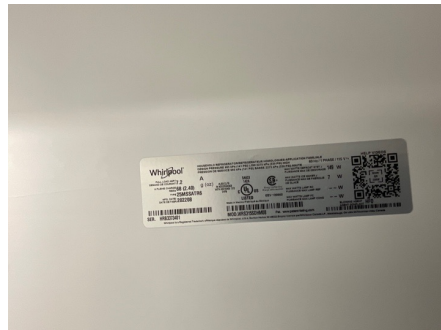
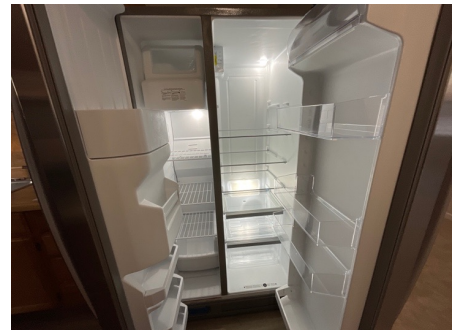
The refrigerator is plugged into an outlet which is wired in series with the kitchen counter GFCI outlet and is deactivated when the GFCI trips. The refrigerator should have its own circuit and should not be controlled by a GFCI device as the unnoticed tripping of that device can lead to spoilage of the food in the refrigerator.

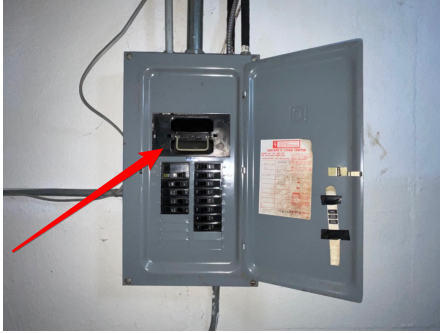
Main disconnect

The main disconnect is incorporated into the electrical service panel.

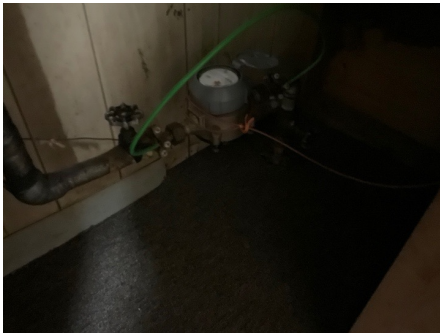
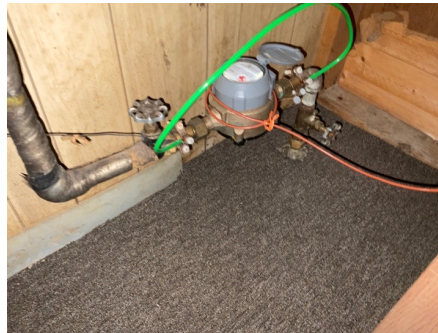
The domestic water supply main shut-off valve is on the front wall in the basement.
